Central Services Facility
6425 Huber Ave.
Detroit, MI 48211

RE: Cave-in Complaint in the Rear of 13566 Rutland Detroit, MI 48227

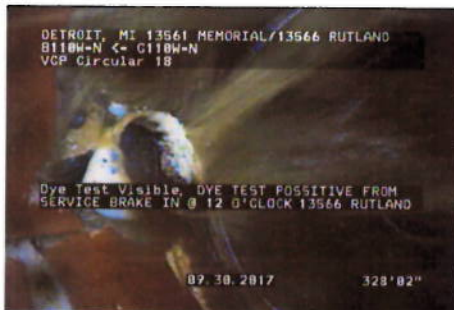
Dye test at the new service connection for 13566 Rutland

The investigation also included Dye Test at the location of the cave-in directly behind **13566 Rutland** to help determine the cause of the cave-in. In this particular case, the dye test was positive through both private service connections from **13566 Rutland**. The positive dye test suggests that the two private sewer services from **13566 Rutland** have failed with direct opening to the cave-in and are allowing water flow and soil migration from the cave-in through the private sewer service connections to the 18-inch public sewer. However, no blockage or

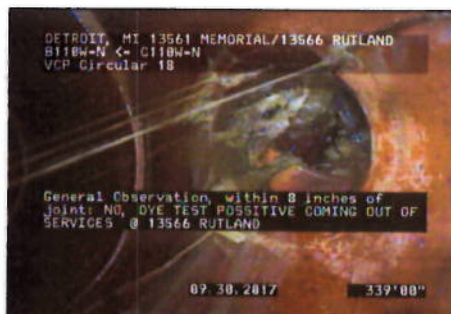
Dye test at the old service connection for 13566 Rutland

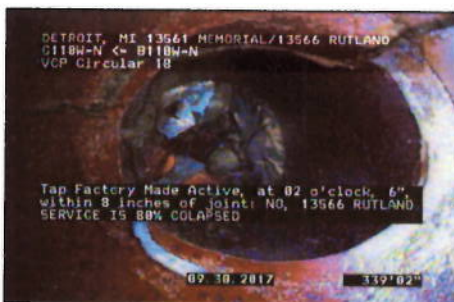
The old service connection for 13566 Rutland 80%

new and the other is old and 80% collapsed.

The failed/collapsed private sewer lead from **13566 Rutland** is the cause of the cave-in in the rear of the property at **13566 Rutland**. Please be advised that customers are responsible for the upkeep of their sewer service connections from the domicile up to the point of connection with the public sewer. If the failed service from the property at **13566 Rutland** has been abandoned and replaced by the new service to the property, then the abandon sewer service line should be properly killed/removed and the resultant cave-in restored by the owner of the property at **13566 Rutland**. If this repair is not done, the cave-in will continue to expand in the alleyway and encroach on private properties of neighbors and may also cause the new sewer service line to **13566 Rutland** to also fail/collapse.

Before excavating to repair or properly abandon the failed sewer service line/connection, obtain Right-of-Way and DWSD permits, and contact Miss Dig. DWSD permit can be obtained at the Water Board Building located at 735 Randolph Suite 104, Detroit, Michigan 48226.

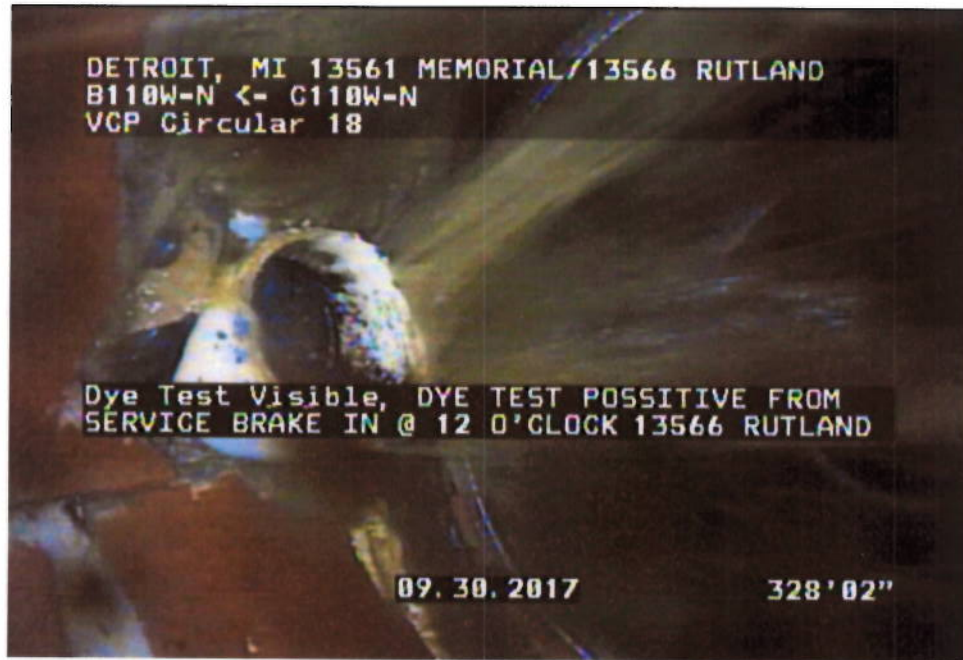
Dye test positive at service connection for 13566 Rutland (new service)

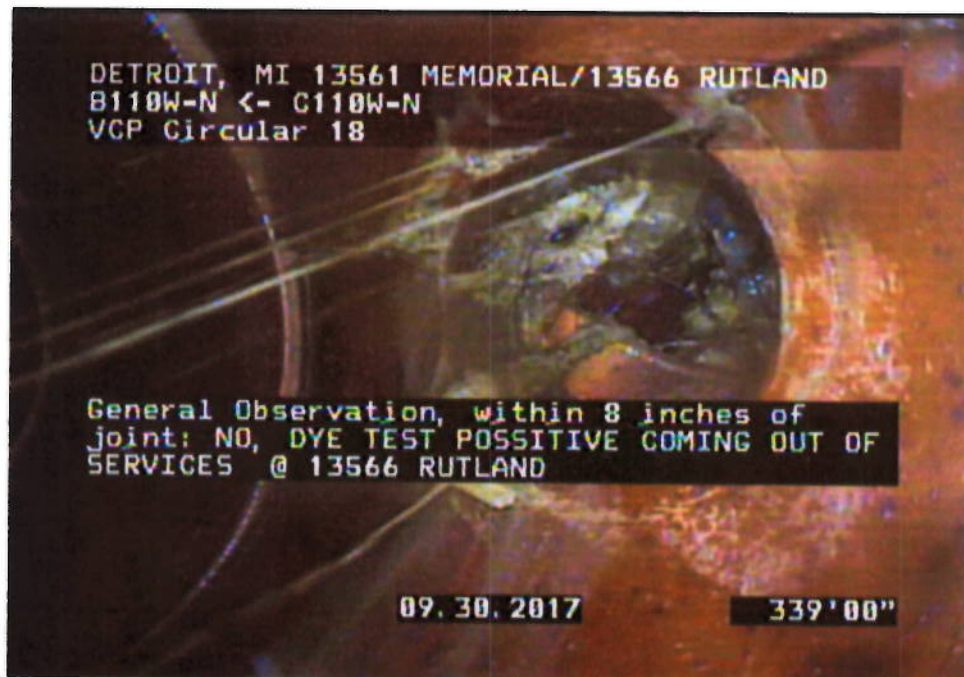
Dye test positive at service connection for 13566 Rutland (old service)

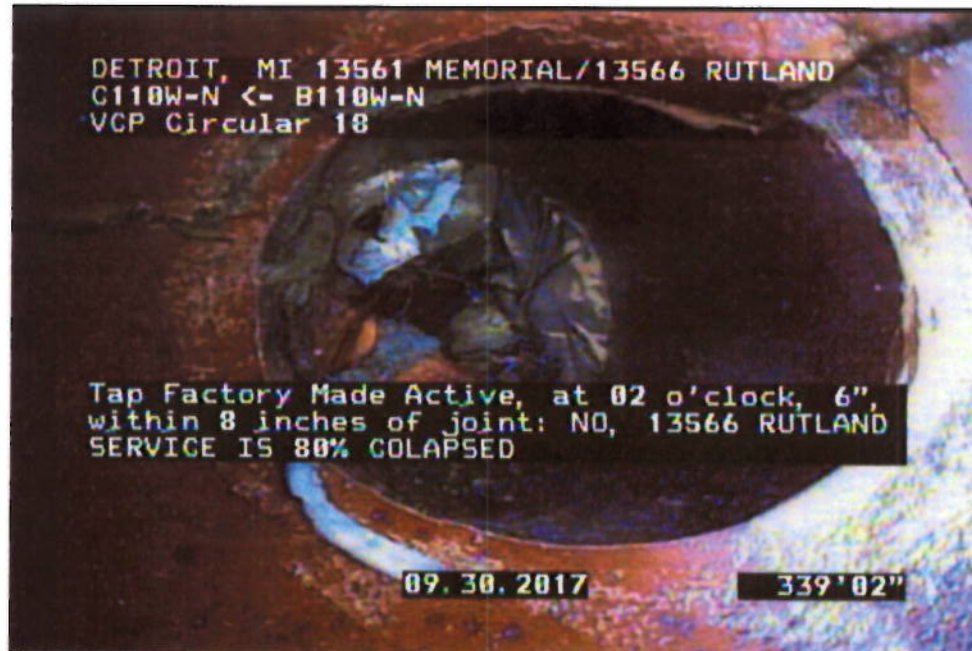
Service connection for 13566 Rutland (old service)
