Re: Public Comment

RE: Water in Basement/Cave-in Complaint at 1547 Clairmount, Detroit MI 48206

RE: Cave-in Complaint in Rear Alleyway at 1550 Taylor, Detroit MI 48206

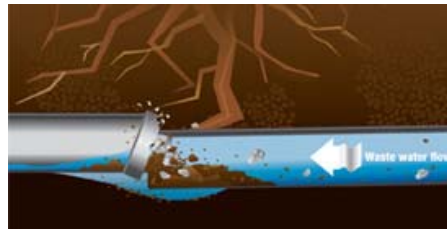
Detroit Water and Sewerage Department (DWSD) has investigated the complaint regarding the basement backup and cave-in of the rear alleyway. A review of all work orders regarding this address indicate that 1547-49 Clairmount and 1550 Taylor both have private issues with the sewer service connection. The defect in the private connection for both properties is the proximate cause for the cave-in. Per our discussion at the BOWC meeting, you believed that the stone fill used to secure the cave-in caused the basement backups. A review of the video inspection which was done after the hole was filled with stone, does not show stone in the public sewer or the riser to the private connection servicing 1547-49 Clairmount. This further substantiates that the public sewer is free from defect. With the offset of the services for both 1547-49 Clairmount and 1550 Taylor, the unrestricted flow of sewage over multiple years caused soil erosion which led to the cave-in of the rear alleyway, as illustrated by the graphic below:

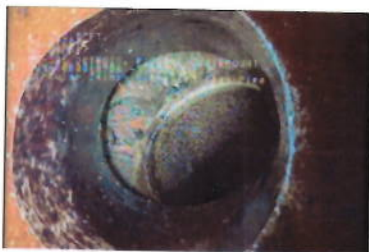
1547 Clairmount – Private Service Connection

the property at **1547 Clairmount**. The investigation also included a Dye Test at the location of the cave-in. The result of the investigation is explained below. The CCTV inspection of the 24-inch public sewer and manholes in the rear of the property at **1547 Clairmount** involved televising the public sewer and all sewer service connections along the public sewer from the manhole located in the middle of the Alley-way between Clairmount and Taylor west of Byron to where the 24-inch sewer blind ties into the 3'-10"x5'-9" sewer in Woodrow Wilson. The investigation also included a dye test at the location of the cave-in behind **1547 Clairmount** to help determine the cause of the cave-in. In this particular case, the dye test was positive at the service connection from **1550 Taylor** and also from **1547 Clairmount**. The investigation also showed that the private sewer connection for **1547 Clairmount** was about 40% offset.

The positive dye test along with 40% offset of the private sewer connection suggest that the private sewer line from **1547 Clairmount** has failed with a direct opening to the cave-in and is allowing water flow and soil migration from the cave-in through the private sewer service connection to the 24-inch public sewer. However, no blockage or failure was found on the 24-inch public sewer that could be associated with the causes of the cave-in or affect the flow in the 24-inch public sewer to cause the WIB at **1547 Clairmount**. A "Fix It" letter is also being mailed to the neighbor at **1550 Taylor** whose private sewer connection was also found to be a contributing cause of the cave-in.

The failed private sewer connections from **1550 Taylor** and **1547 Clairmount** are the cause of the cave-in in the alleyway. The private sewer failures may also cause sewer back up at both properties. Please be advised that customers are responsible for the up keep of their private sewer service lines from the domicile up to the point of connection with the public sewer.

Before excavating to repair the failed private sewer line/connection, obtain Right-of-Way and DWSD permits, and contact Miss Dig. DWSD permit can be obtained at the Water Board Building located at 735 Randolph in Suite 104, Detroit, Michigan 48226.

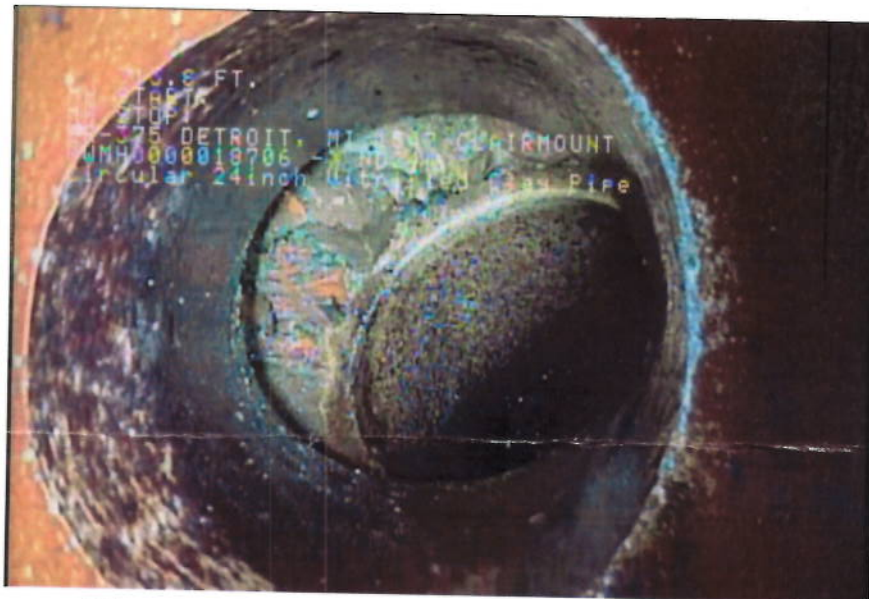
**View Looking up Private Sewer Connection at 1547
Clairmount Showing 40% Offset**

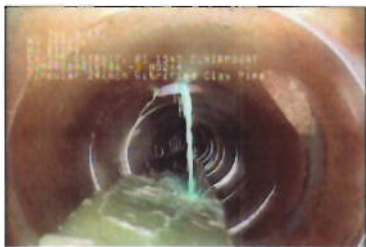
1550 Taylor - Positive Dye Test at service

all private sewer service connections along the public sewer from the manhole located in the middle of the alleyway between Clairmount and Taylor Avenues west of Byron Avenue to where the 24-inch sewer blind ties into the 3'-10"x5'-9" public sewer in Woodrow Wilson Avenue. The investigation also included a dye test at the location of the cave-in behind **both properties** to help determine the cause of the cave-in. In this particular case, the dye test was mostly positive at the service connection from **1550 Taylor and also from 1547 Clairmount**. The positive dye test suggests that the private sewer service line from **1550 Taylor** has failed with a direct opening to the cave-in and is allowing water flow and soil migration from the sinkhole through the private sewer service connection to the 24-inch public sewer. However, no blockage or failure was found on the 24-inch public sewer. DWSD has also sent a letter to the customer at 1547 Clairmount informing the customer of this finding.

The failed private sewer lines from 1550 Taylor and 1547 Clairmount are the cause of the cave-in in the alleyway. The sewer lead failure at 1550 Taylor may also cause sewer back up at 1550 Taylor. Please be advised that customers are responsible for the up keep of their sewer service connections from the domicile up to the point of connection with the public sewer.

Before excavating to repair the failed private sewer line/connection, obtain Right-of-Way and DWSD permits, and contact Miss Dig. DWSD permit can be obtained at the Water Board Building located at 735 Randolph in Suite 104, Detroit, Michigan 48226.

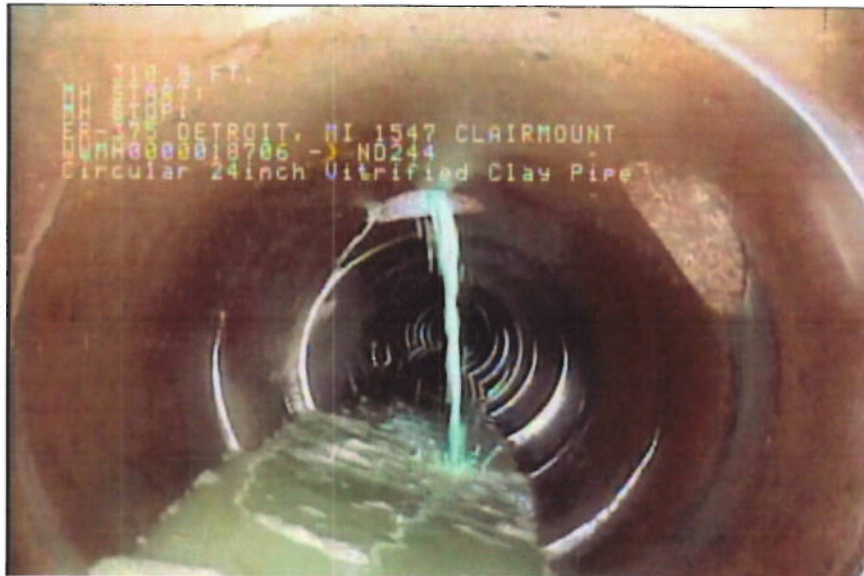
**Looking Down 24-inch Public Sewer at Connection for 1550 Taylor
With Positive Dye Test**
